Restoration Crafts and Practises at Seidla Manor in Estonia

—Sustainable Heritage Report No. 2

Novia Publications and Productions,
series S: Student Works, 3/2012

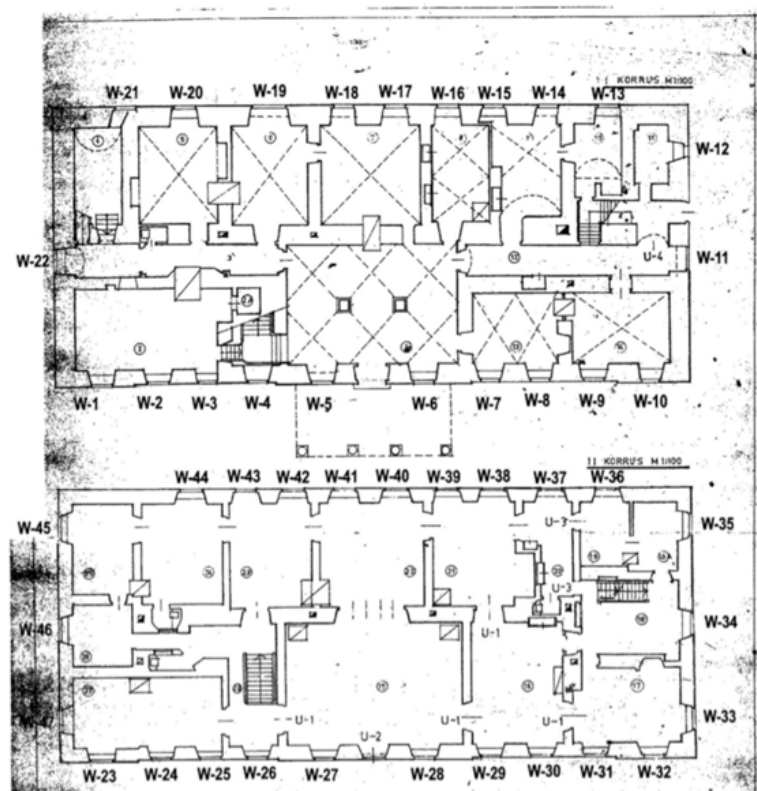
Figure 1.1. Plans of Seidla Manor with the window labels.

1. First of all it is necessary to mark each window on all plans or all facades, labelling every window with a letter and a number e.g. W-1 and W-2 (W for window). The letter indicates the kind of construction we are dealing with: Usually windows are marked 'W' and the doors would have letter 'D'. This kind of labelling makes the work faster and systematic. The place where to start numbering is not as important as the fact, that each window should have its own unique code which will later be used in the header of the inventory sheet. All the windows must be taken into account, including the balcony windows and small windows in the cellar or the roof. If there is not any ground plan available from archives, then it has to be drawn schematically on the spot. The inner and outer casements do not have to be numbered separately, because they will be dealt with separately on the inventory sheet.

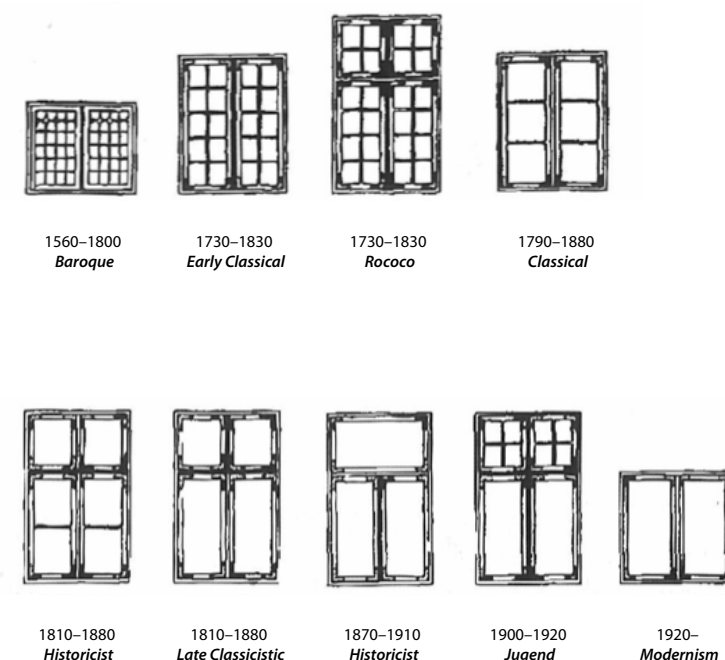
Figure 1.2. Common window types in Estonia.²

2. When the paperwork is prepared, the inventory work can begin. The first step is to observe visually all the windows of the building, in order to obtain a reasonable overview of the different shapes and types. Every window should be marked with a sticker carrying the code as indicated on the plan or facade. Only then, every window has to be examined by its shape and size in order to determine the type. In this way it is easy to figure out how many windows from different periods there are. Most common historical window types in Estonia are presented in figure 1.2.

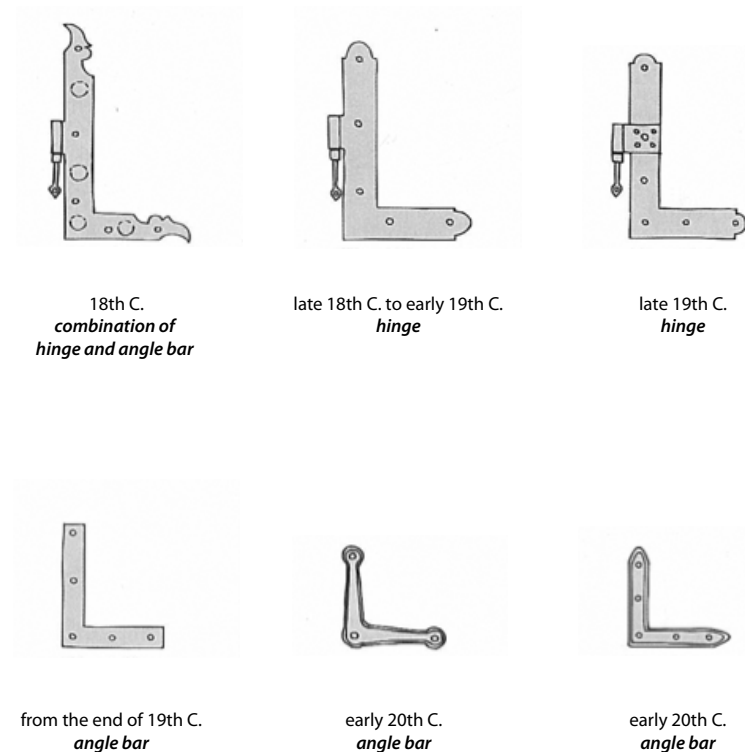
Figure 1.5. Examples of historical fittings in Estonia.

Fittings are used for practical purposes: e.g. angle bars strengthen the joints; hinges, hooks and Cremonas help to close the window. In addition, fittings give a lot of information about the historical style of different periods. See figures 1.5 and 1.8 a–d for the different types of ironmongery that could be found on the windows of Seidla Manor.

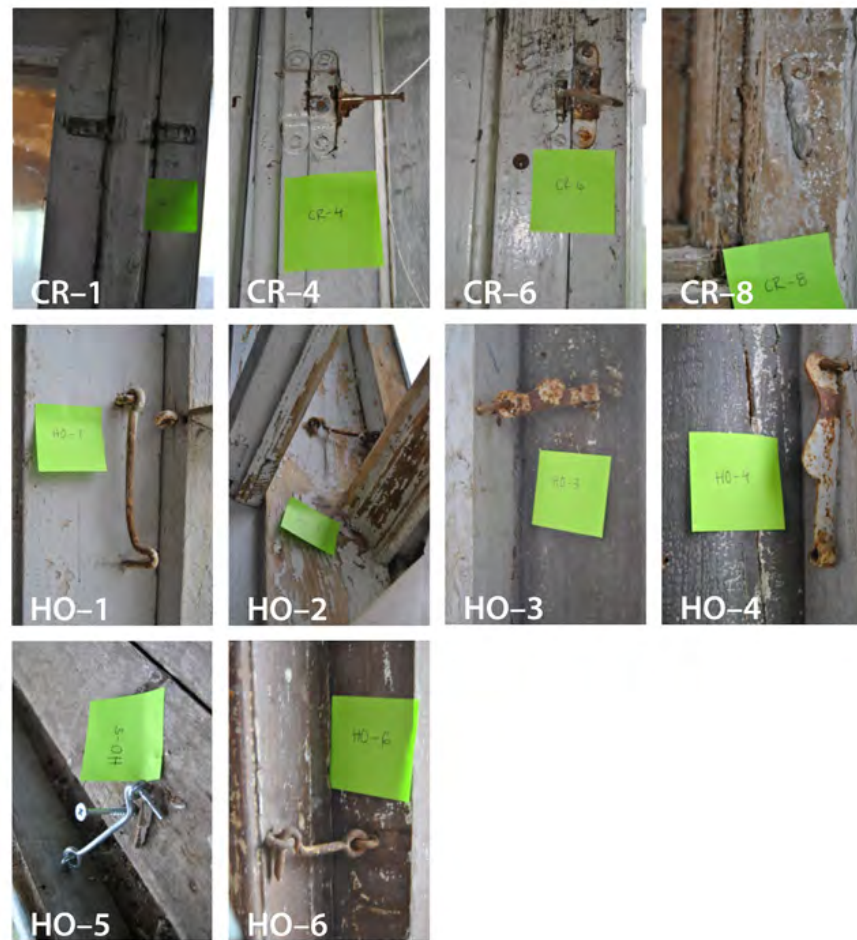
Figure 1.8 c. Cranks and hooks: CR-(1-3) and HO-(1-6).

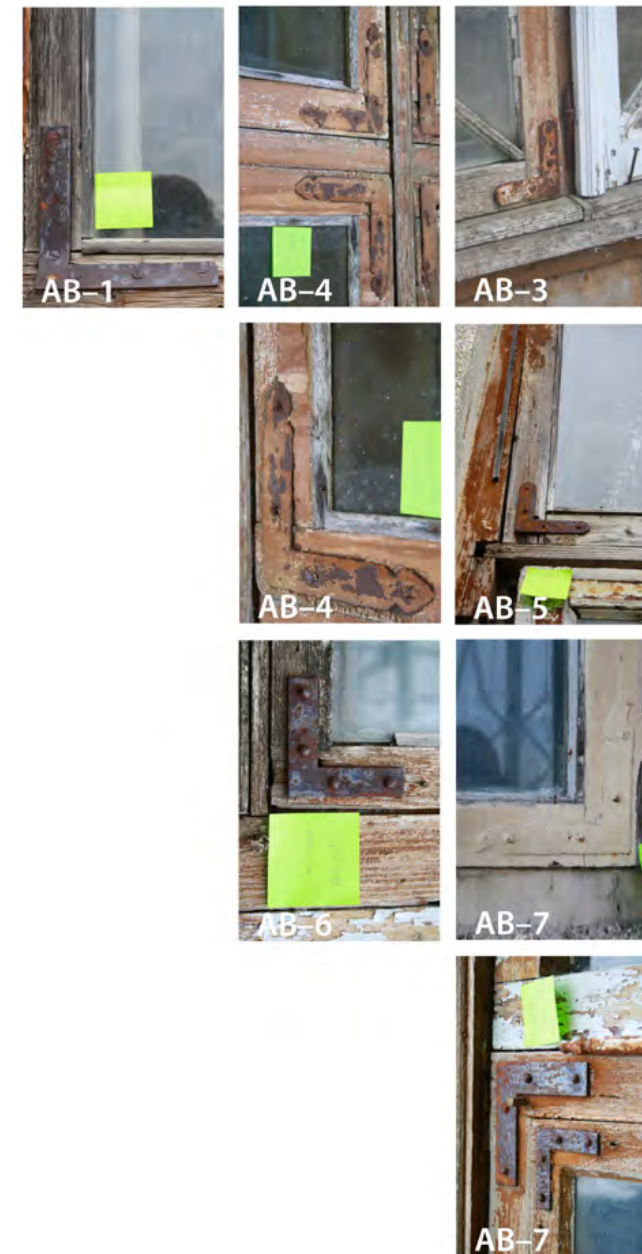
Figure 1.8 d. Angel bars: AB-(1-8).

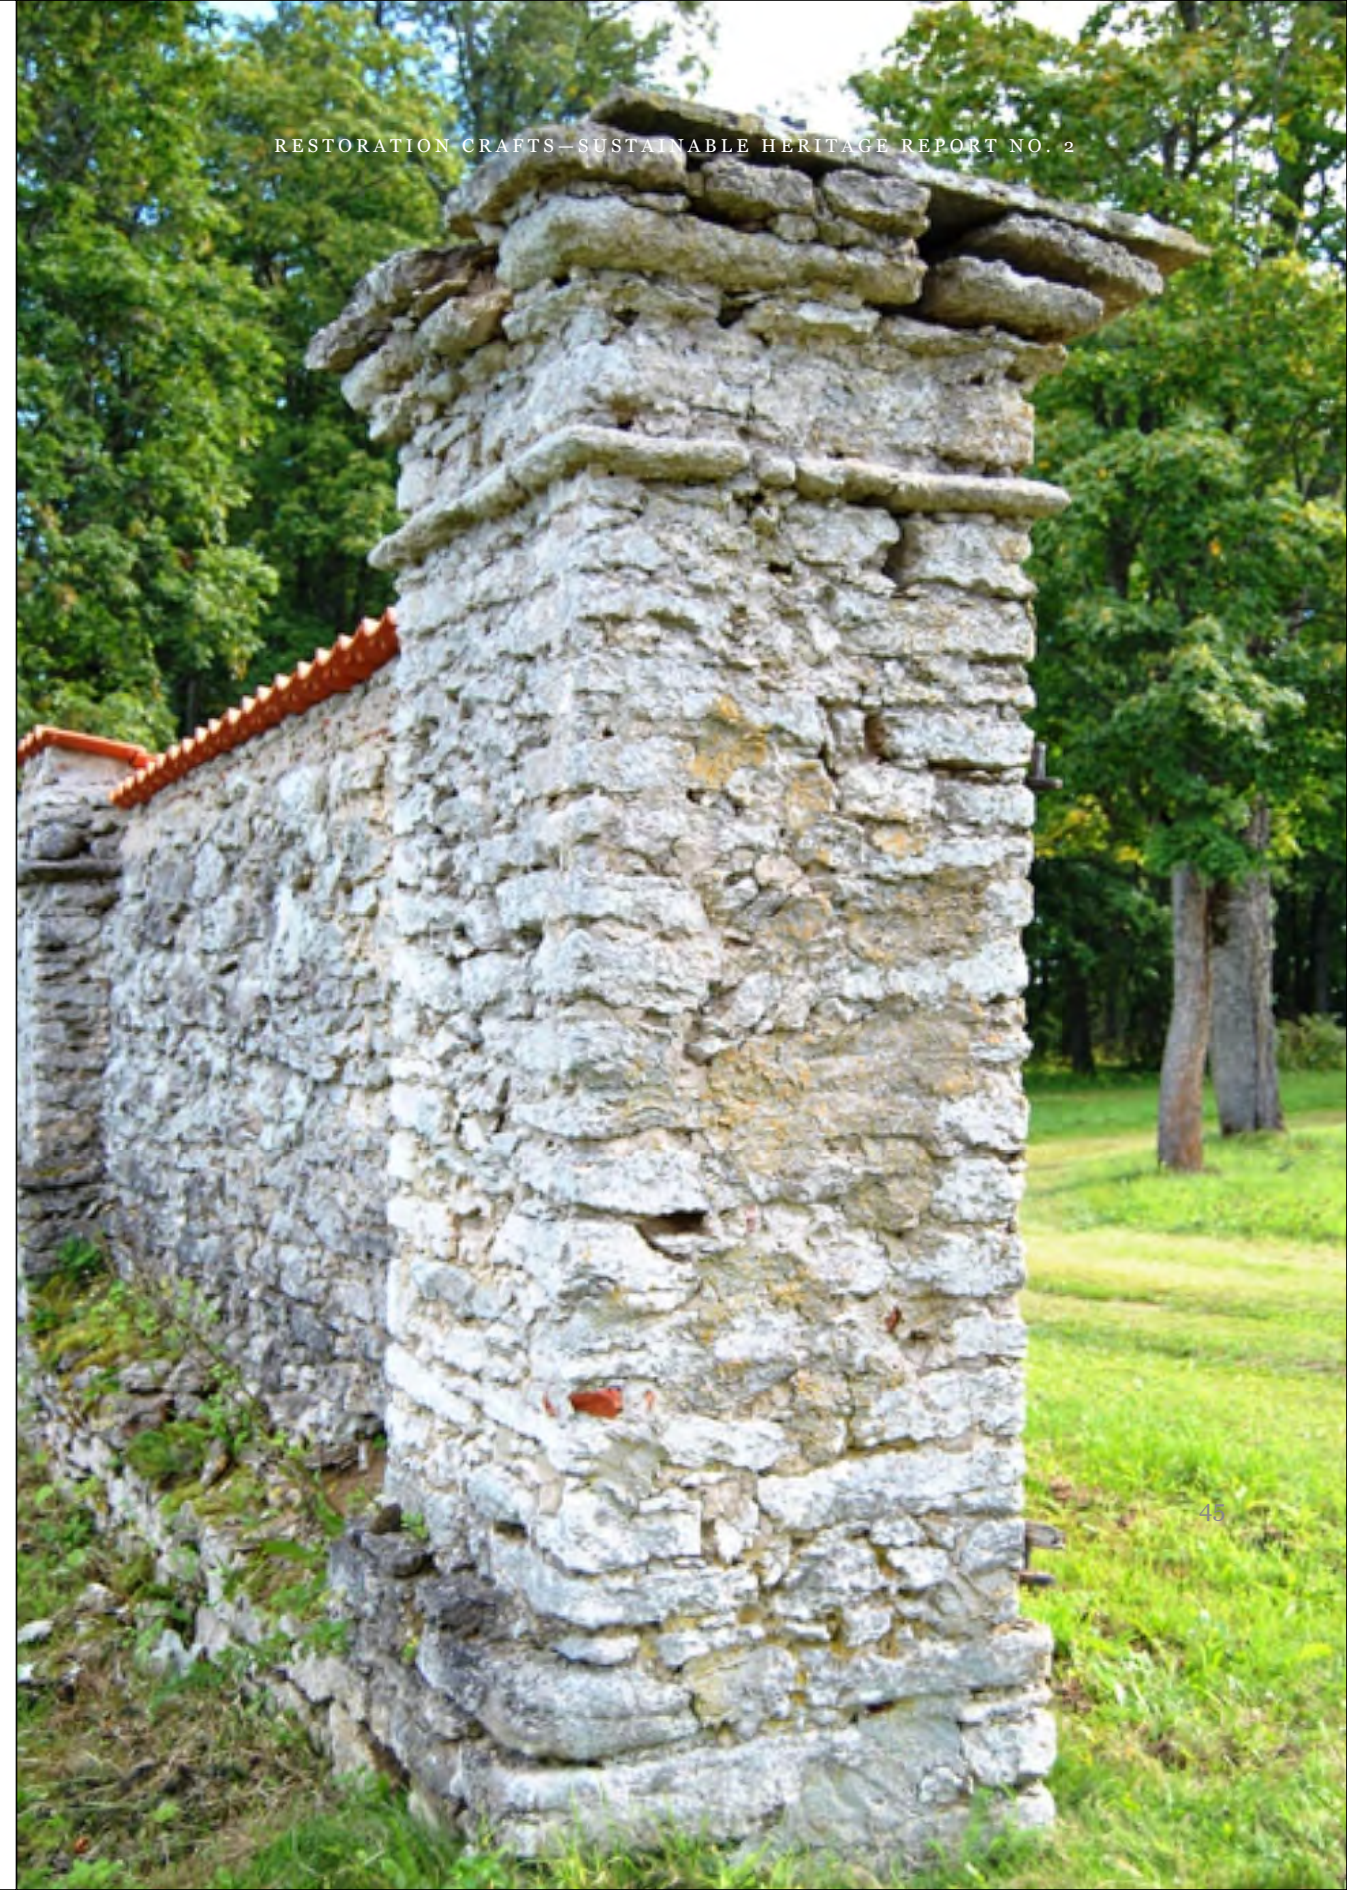
Figure 2.4. Decayed mortar allows rain and frost into the structure thus accelerating the process of deterioration.

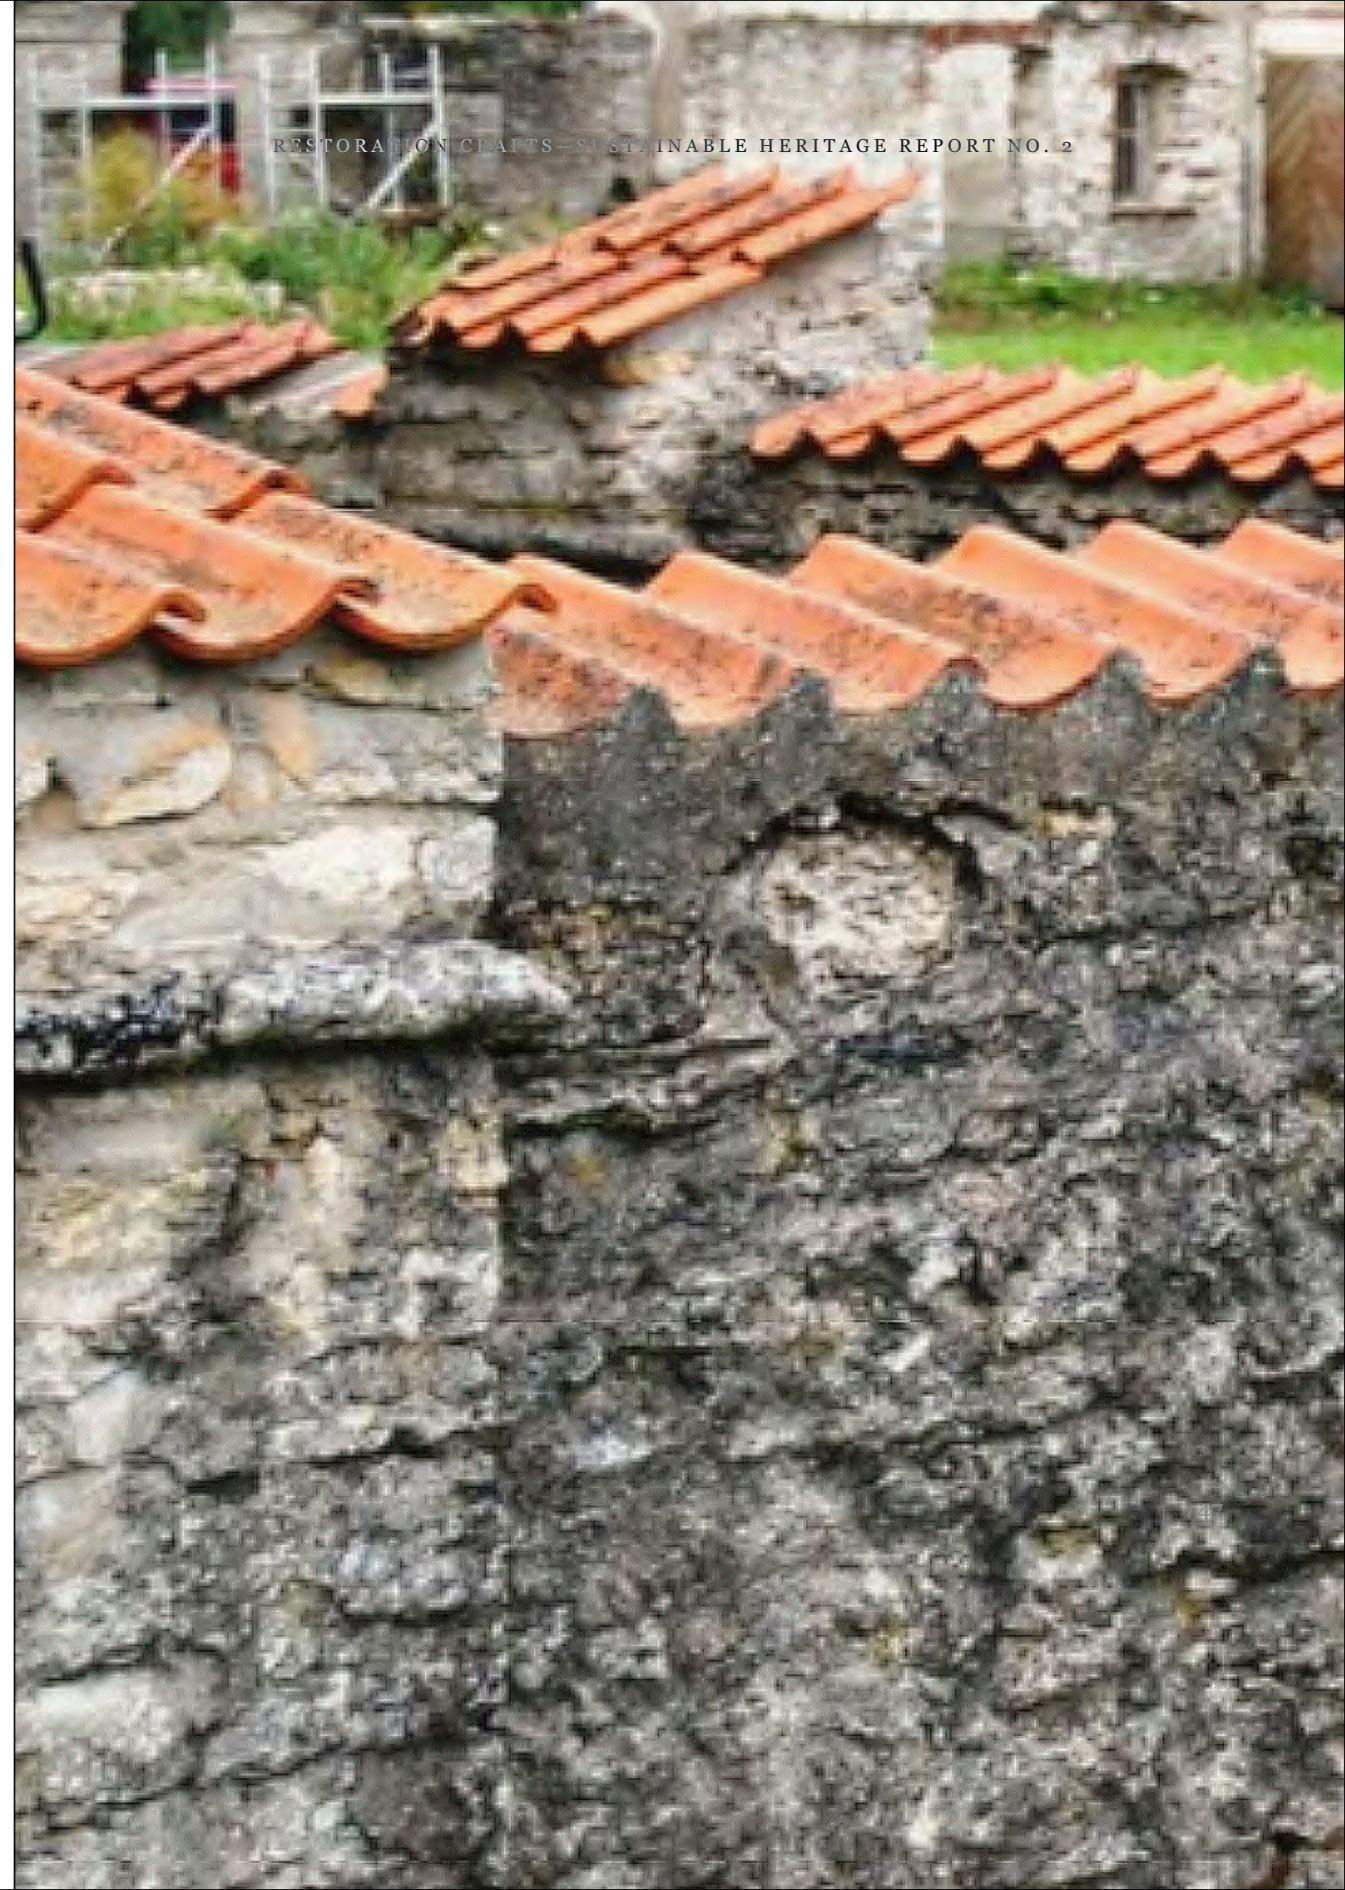
Figure 2.5. The terracotta roofing tiles are a later addition to the wall. The installation might not look very elegant but at least it prevents rain from entering the structure.

Instead of flagstones roofing tiles can be used as a top layer to protect the top of a wall. This is the case on most parts of the garden wall at Seidla Manor. The top of the wall has been built with a slope, using broken roofing tiles as a filling and a cement mortar to fix it together. This is clearly a later addition as the mortar is newer than the old lime mixture, and the roofing tiles are also of a younger date than the wall itself. Some parts of the wall have been left without this addition. There the top layer consists of lime stone and has a slight angle to lead the water off.

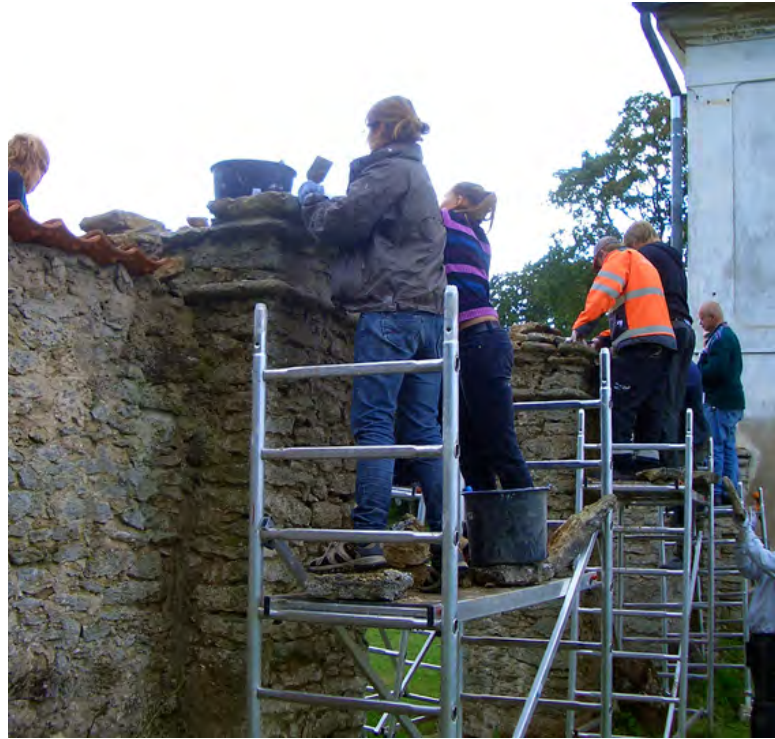
Figure 2.9. Estonian students working on gatepost C in the front; Finnish students in the middle, studying post B, and Swedish students busy with post A in the background.

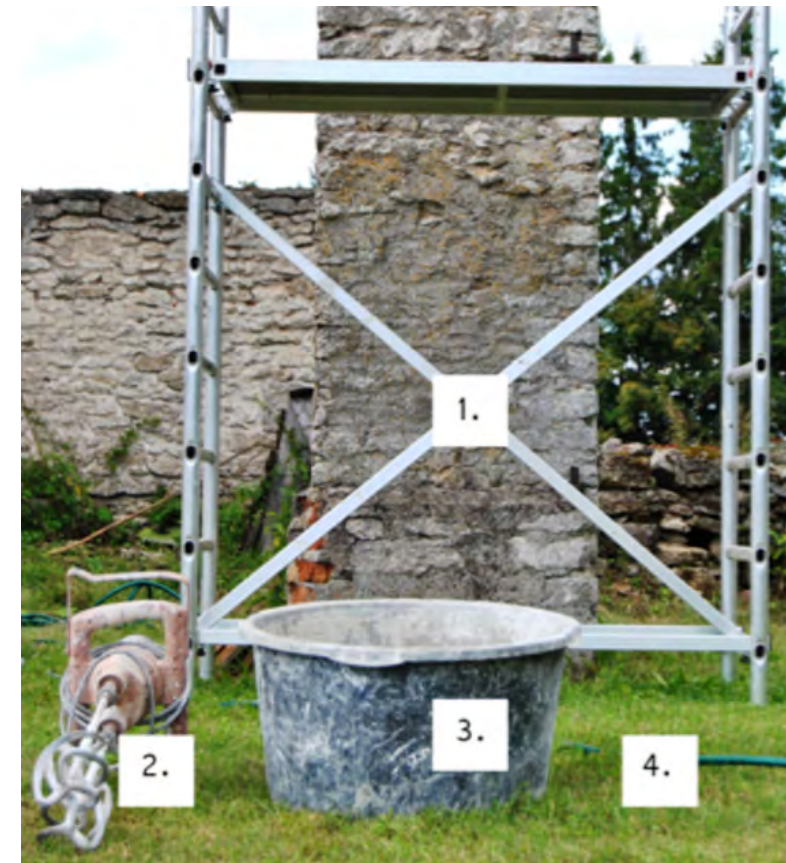
Figure 2.10. Tools: scaffolding (1)—used to reach the top of the posts; buckets (2)—used for mixing the mortar and lifting it up on the scaffolding; mortar mixer (3)—used for mixing the mortar in the bucket; water hose (4)—used for dampening and cleaning the surface of stones and cavities of the wall before applying the mortar. Water was of course needed in the mortar, too.

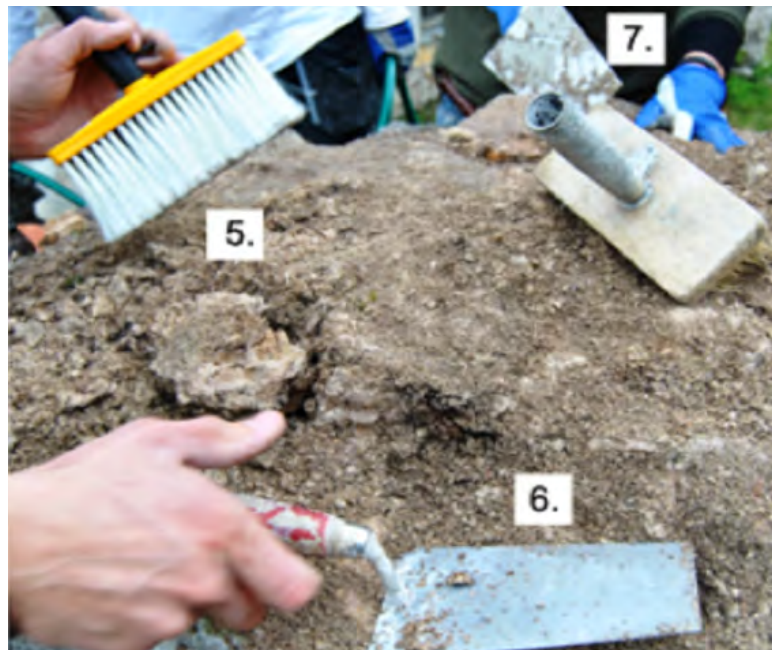
Figure 2.11. More tools: brushes (5)—used to wipe off sand and also to even out mortar on the sides of the posts; trowels (6)—used to apply the mortar onto the wall; waterproof gloves (7)—used when handling the mortar to prevent direct contact with lime; tape measures used for documentation.

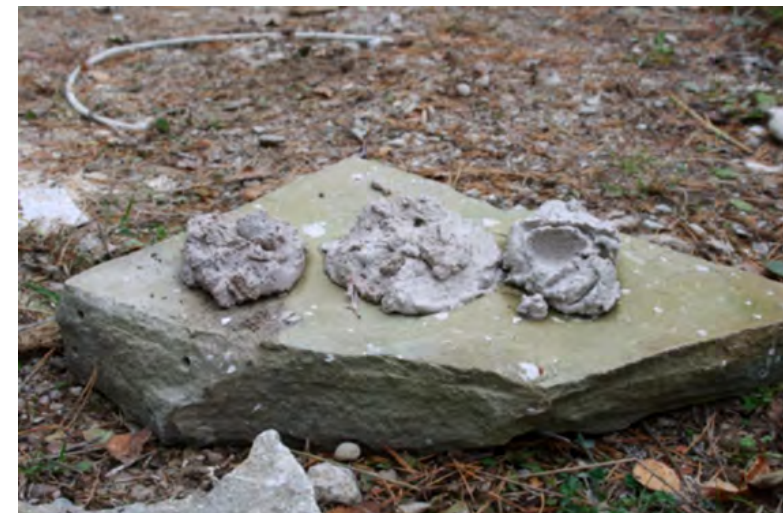
Figure 2.12. Samples of new mortar.

During the documentation it can also be a good idea to take samples of the mortar and render to identify it, either by asking an experienced bricklayer or sending it off to a lab for examination. This will answer the question of what mix to use.

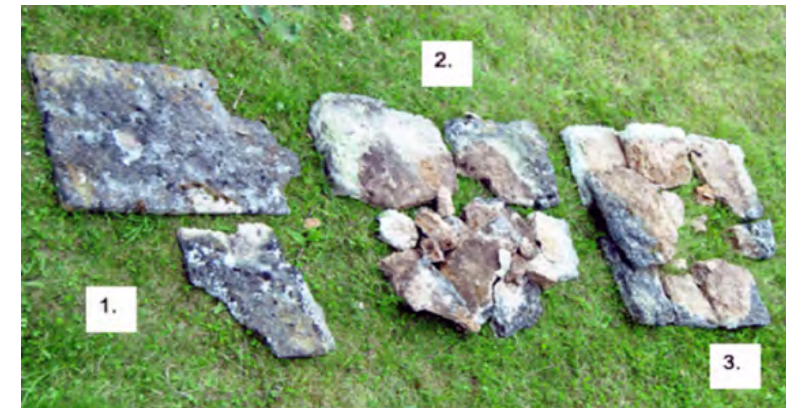
Figure 2.14. Dismantled stones from gatepost: top level (1), second layer (2)—middle part, and right—third layer from top, bottom part of gatepost profile (3).

After the removal of the old plaster and top stones we organized the stones on the ground in the same pattern as they were on the wall.

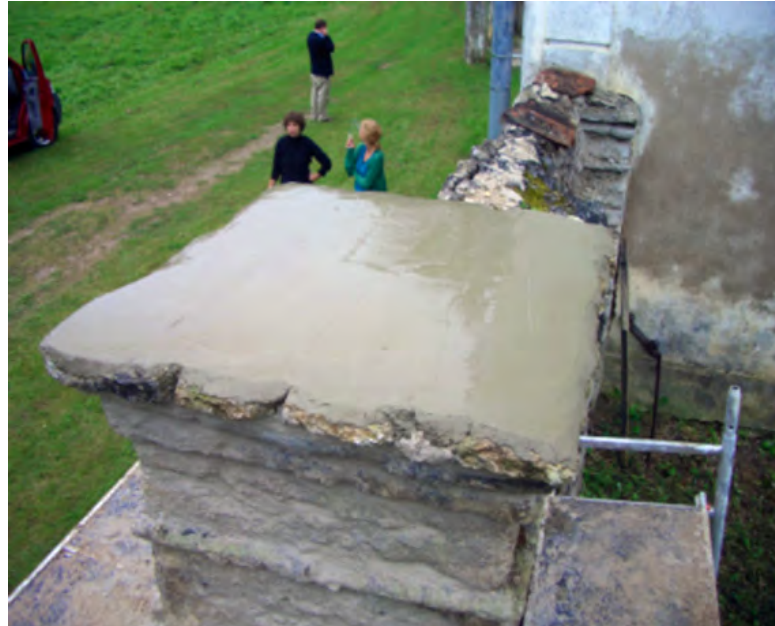
Figure 2.15. The broken flagstones on top of garden posts A and B had to be replaced with a topping of cement mortar because similar new stones were not available.

On the garden posts at Seidla Manor we did not do any rendering, but left them with a rough surface instead. Cavities were filled roughly and the mortar was left to settle over night. On the next day excess mortar was washed and brushed away to match the surface with the rest of the weathered wall.

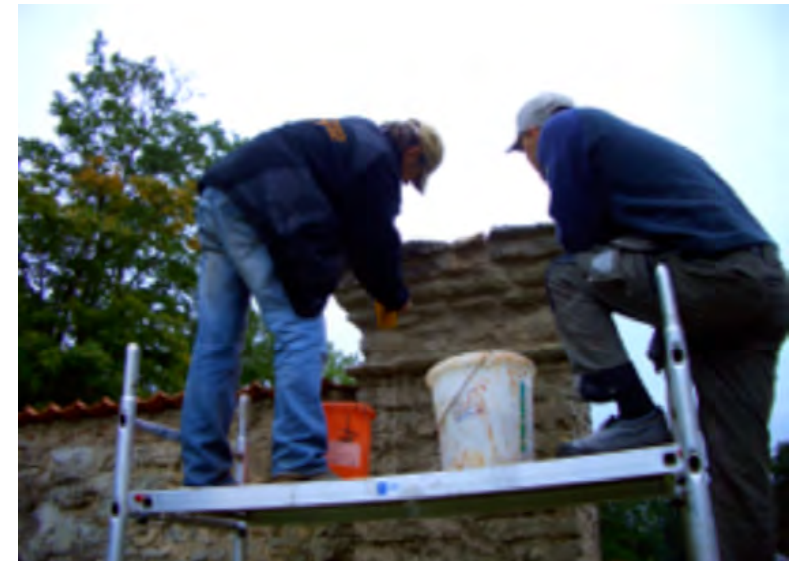
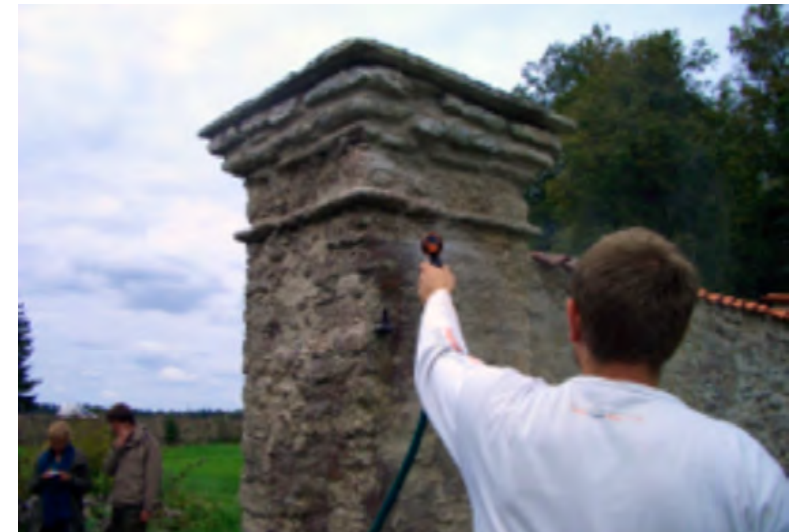
Figures 2.16–17. Finishing touches are being applied on gatepost C.

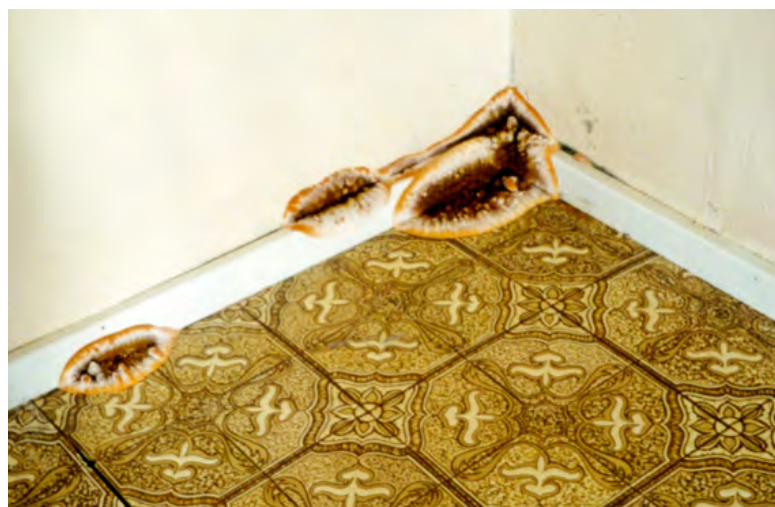
Figure 3.1. Fruiting bodies of *Serpula lacrymans*.

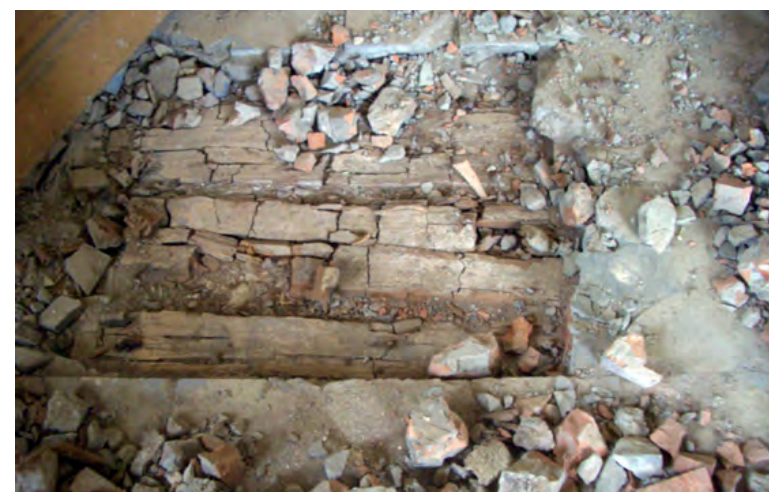
Figure 3.2. Seidla Manor. Floor boards are cracked by fungi. The topmost layer of bricks and plaster has not allowed rising damp to evaporate from the underlying wooden construction.

Seidla Manor had several examples of brown rot. The fungi were not very active since the roof had been repaired and the wood work had dried together with the indoor climate.

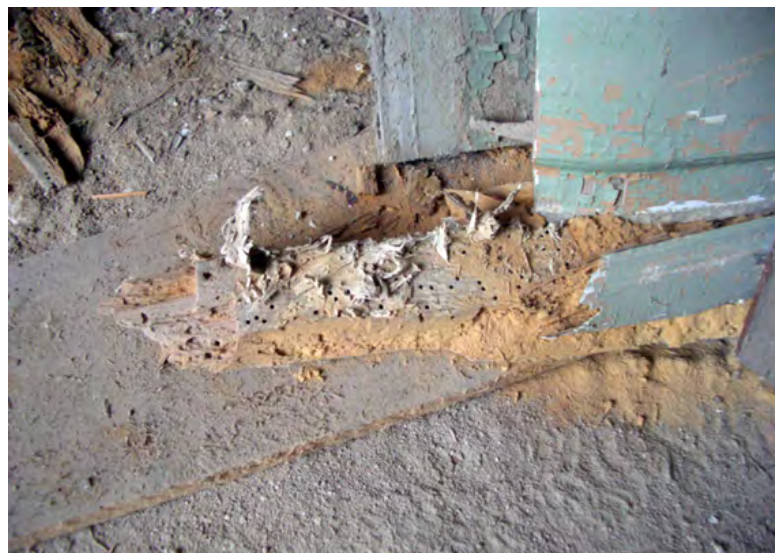
Figure 3.3. Seidla Manor. Top left: brown rot; center: white rot and destruction by wood boring insects.

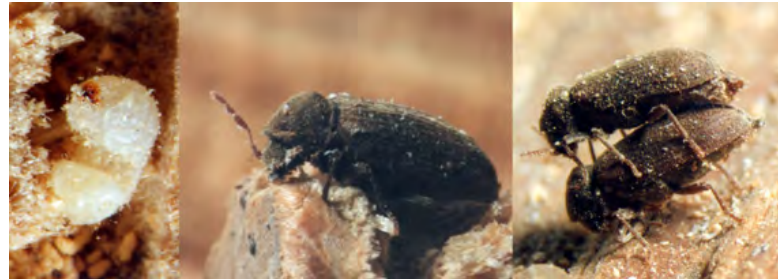
Figure 3.4. Anobium punctatum. Due to its small size this creature is a slow actor in the destruction business. This beetle disfigures antiquities but a day or two in a freezer or out of doors during cold winter days will kill it.

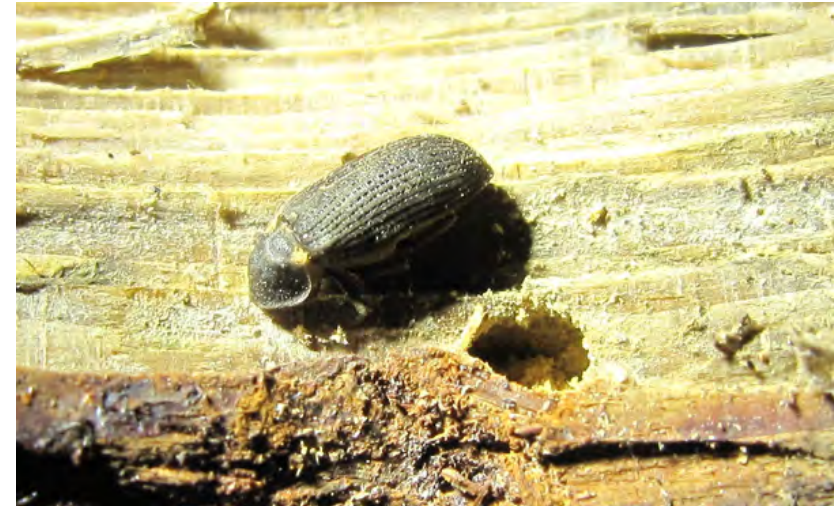
Figure 3.5. Hadrobregmus pertinax or Anobium pertinax, the insect that causes most trouble in buildings in our part of the world.

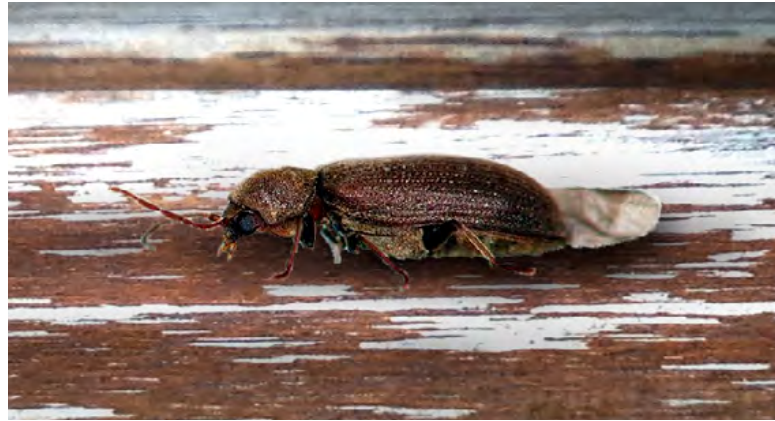
Figure 3.6. *Hadrobregmus confusus* is very much like *Hadrobregmus pertinax* but not so common in buildings.

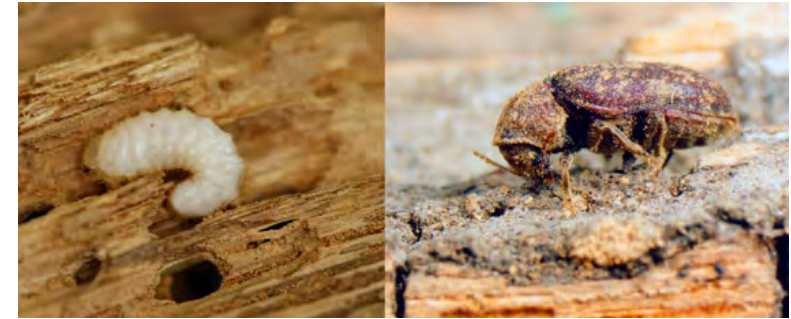
Figure 3.7. *Xestobium rufovillosum*.

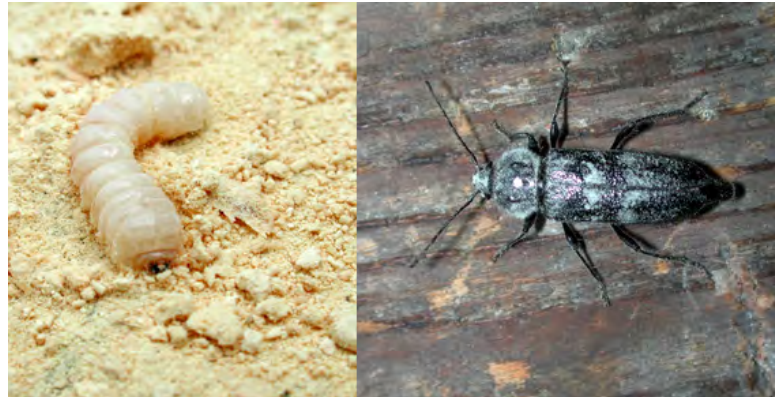
Figure 3.8. *Hylotrupes bajulus*, the most feared visitor in attic spaces. Its big and energetic larvae dig wide tunnels and due to its short life cycle the insect multiplies in large numbers.

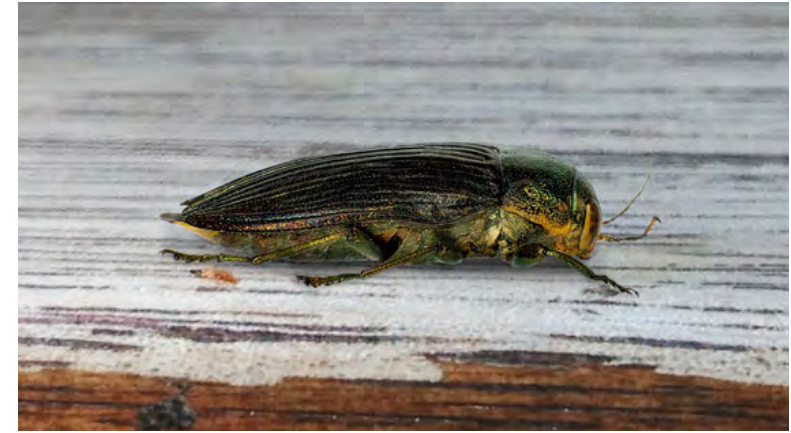
Figure 3.9. *Buprestis haemorrhoidalis*. This beetle can be up to 20 mm long. It likes softwood (pine). The larvae live in dry wood, maybe on the sunny side of a building. Fairly rare in the northern part of the Baltic Sea region but more common the further south you go.

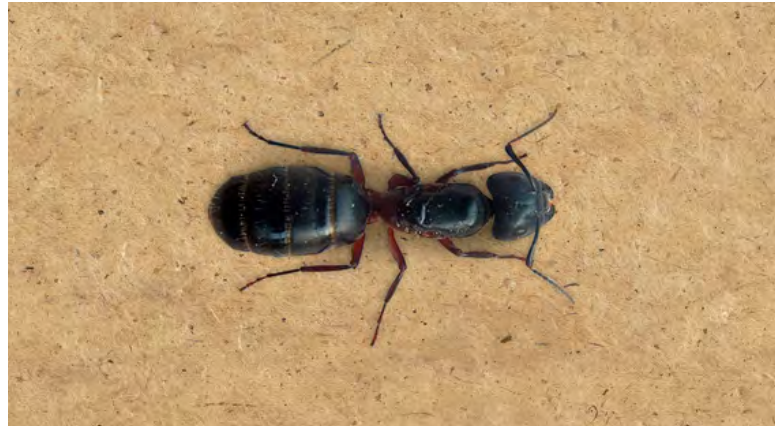
Figure 3.10. Camponotus herculeanus usually builds nests in decaying wood both out of doors and inside timber structures. The damage is usually local but a big nest can cause failure of a structural member. The ant is 6–18 mm long and in one colony there may be thousands of individuals. They are difficult to get rid of but it helps if you find their queen and remove her.

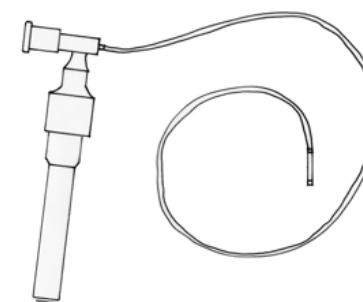
Figure 3.11. An endoscope. The scope may be attached either to a flexible or a rigid tube.

Endoscope: An endoscope is a tool which helps you investigate areas inaccessible to the naked eye. There is a whole range of different endoscopes, smaller and bigger, cheap ones and expensive ones. Simple bore scopes consist of a light source, a thin rigid tube with built-in optics and an eye-piece. By drilling a small hole, usually less than 12 mm, and inserting the tube, it is possible to inspect voids under floors and behind paneling. Any hidden problems such as fungal growth can in theory be found but to understand the transmitted images requires experience.

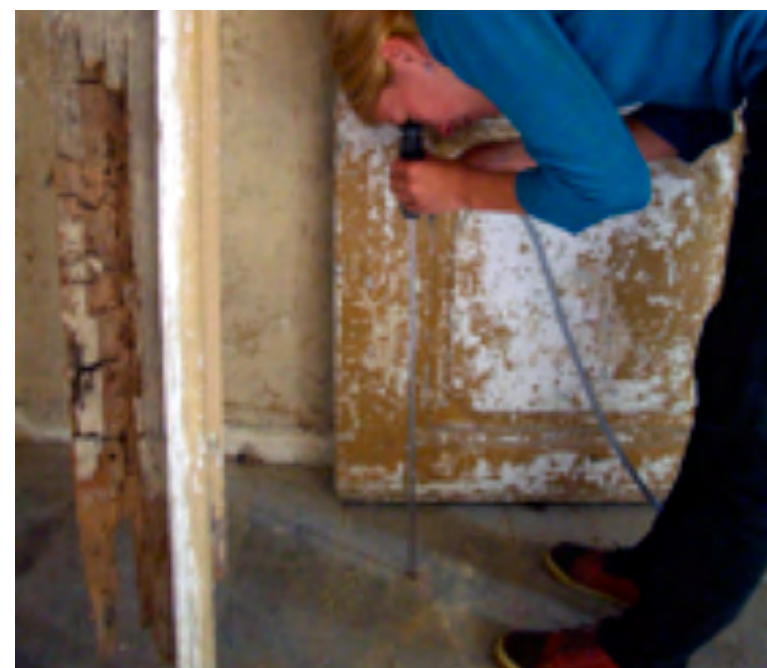
Figure 3.12. Some fungi could be detected underneath the floor boards of the upper hall at Seidla Manor.

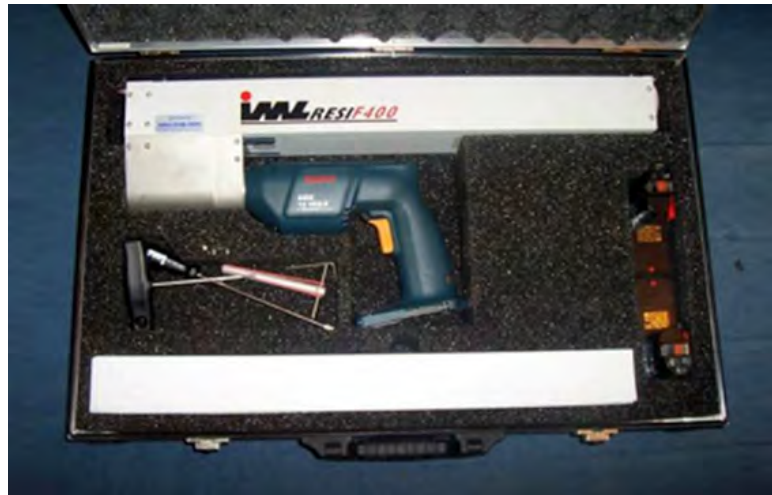
Figure 3.13. Micro drilling apparatus.

Micro-drilling: micro-drilling is the best technique available today for investigating timber. A 1 mm drill probe which is attached to a computer penetrates up to 200 mm into the timber and records faults by measuring the speed of penetration. The extent of decay and its position can thus be determined. The information is extremely valuable for engineers who need to calculate the load bearing capacity of old structural timbers and decide on methods of repair.

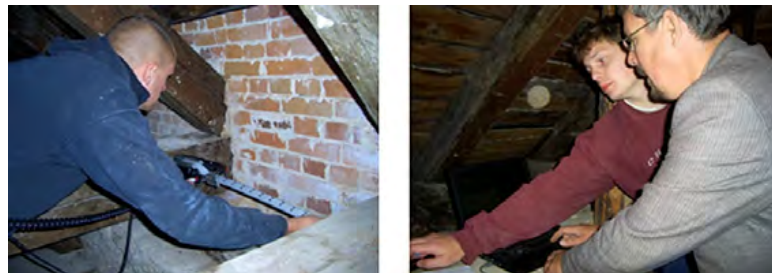
Figures 3.14. One student is drilling into a roof truss while the other is learning to interpret the transmitted information on the computer. Prof. Kalle Pilt, lecturer at Estonian University of life Sciences, (far right) is explaining the curves on his computer screen.

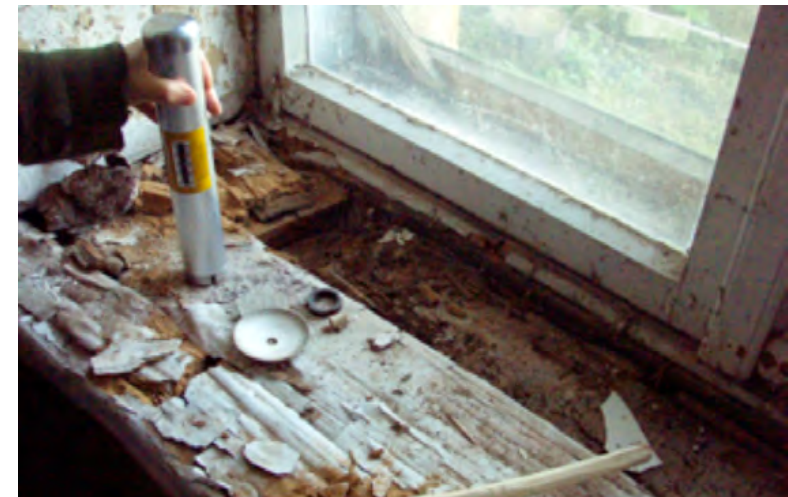
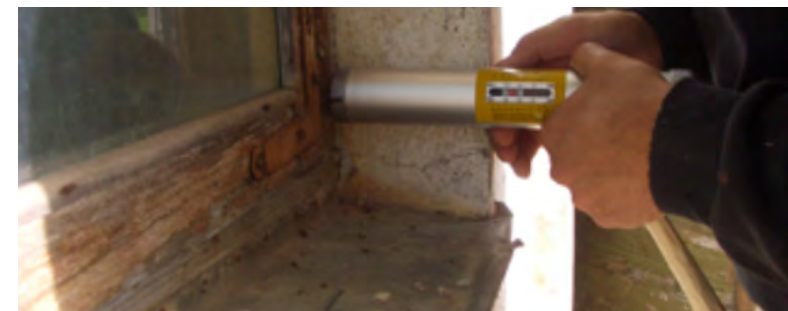
Figures 3.15–16. The Pilodyn was tested on timber with various degrees of decay.

The Pilodyn is used on many different wooden objects for testing the rate of decay as well as wood quality in general, e.g. of railway sleepers, structural timbers in houses, wooden bridges, fence poles...

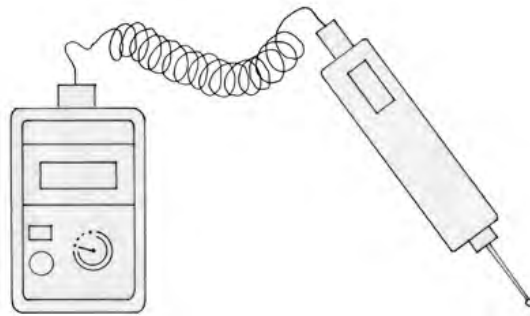
Figure 3.17. Electronic moisture meter.

Moisture measurement: Electrical resistance meters do not give information about the moisture within the timber because they can only measure the moisture content on, or just below the surface of timber. Old surface treatments can also change the resistivity of the timber and give misleading results. Other factors such as foils within the structure, high carbon content of materials, and condensation can give false results. It is important to measure deeper inside a structure to get a reliable result. This can be done by inserting small sensors into holes that are drilled in the timber.

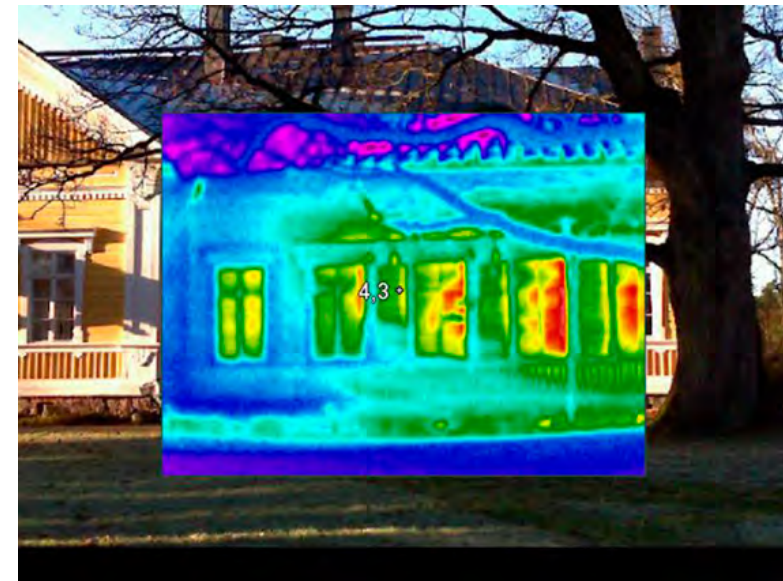
Figure 3.18. Example of an infra-red photo.

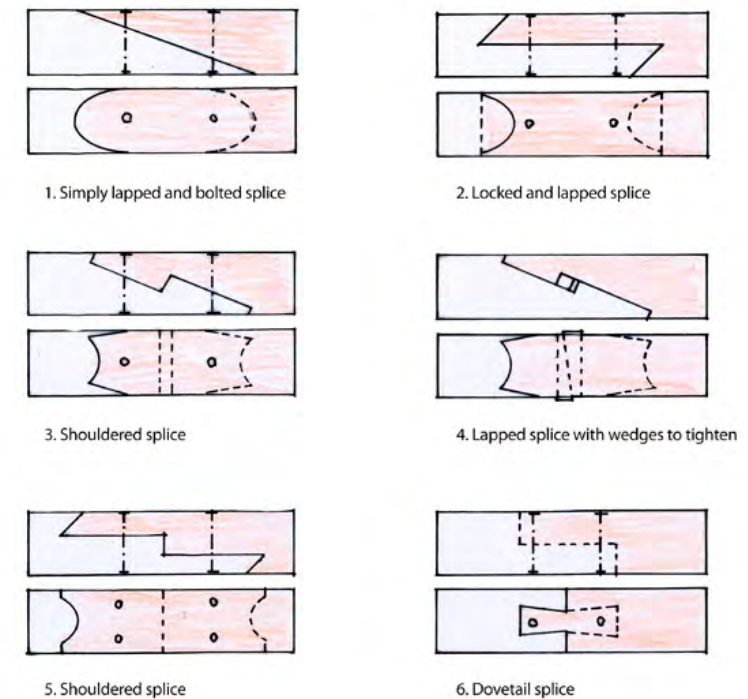
Figures 3.19, 1–6. The shouldered splices above are good examples of joints to use when repairing load bearing beams. Locked and lapped splice can be used when repairing pillars.

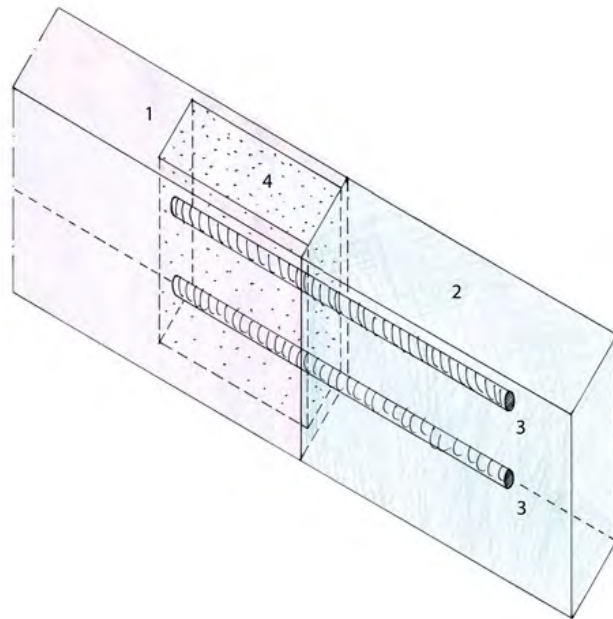
Figure 3.20. In this illustration the timber is reinforced with steel and then a resin mixture is poured into the joint between old and new parts:

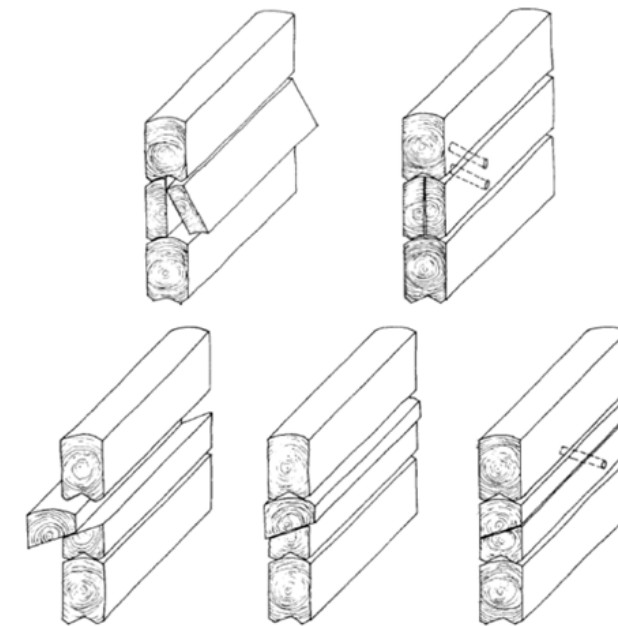
Figure 3.21. By replacing only half the log the rest of the structure can be left untouched. When the new part is in place you should secure it with wooden pegs. (<http://www.nba.fi/fi/File/109/korjauskortti-16.pdf>)

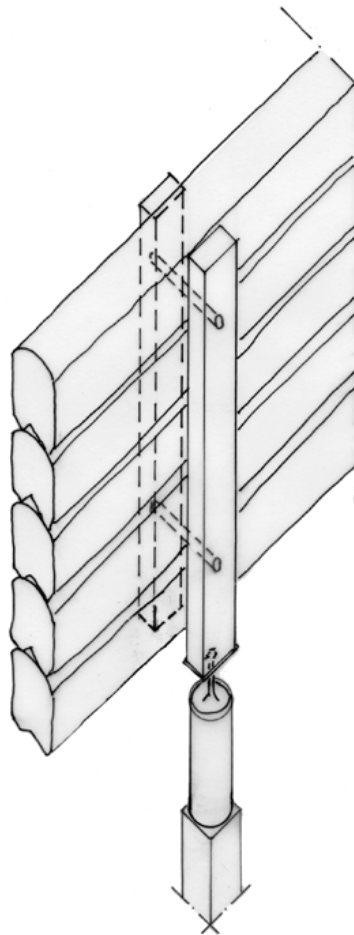
Figure 3.22. Hydraulic jacks are used when sill logs must be replaced and the whole house needs to be lifted. The jacks are placed at strategic points so that the structure can be kept level and secure while carpenters access the structure from the side.
