Restoration Crafts and Practises at Seidla Manor in Estonia

—Sustainable Heritage Report No. 2

Novia Publications and Productions,
series S: Student Works, 3/2012

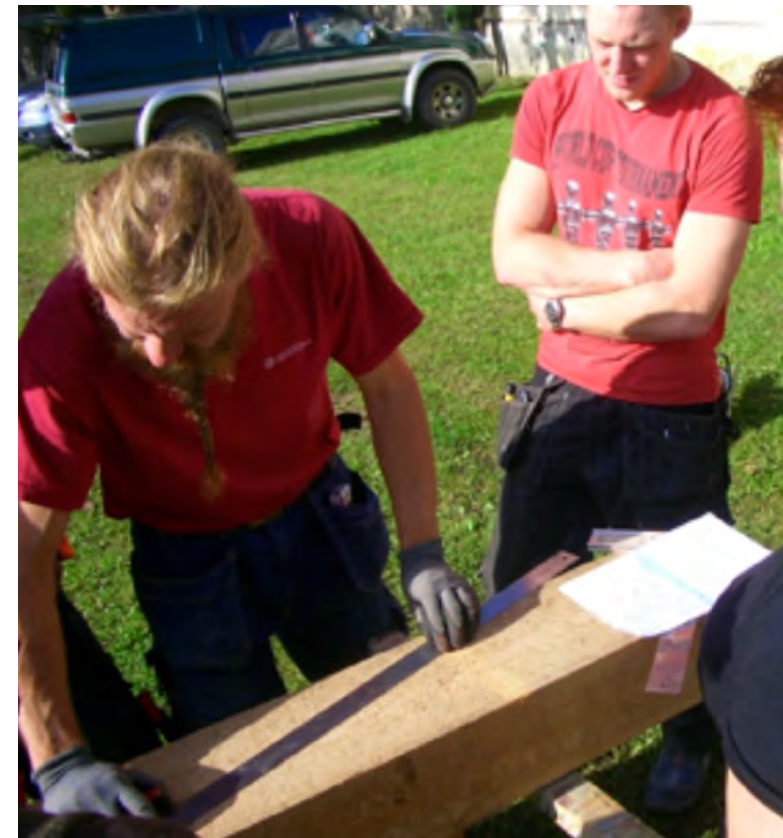
Figure 3.23. Andres Ansper is showing us how to design and draw the joint.

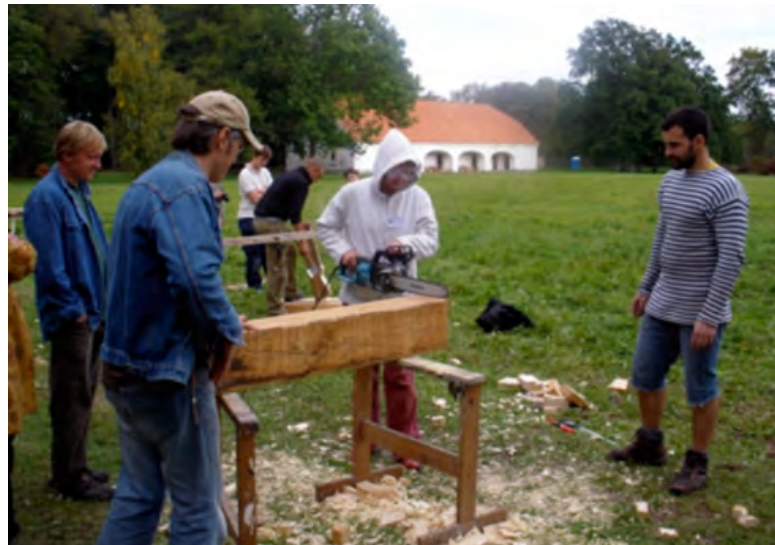
Figure 3.24. Here we are cutting out the splice with a chainsaw. Tarmo Tammekivi (*far right*) is supervising the amateurs.

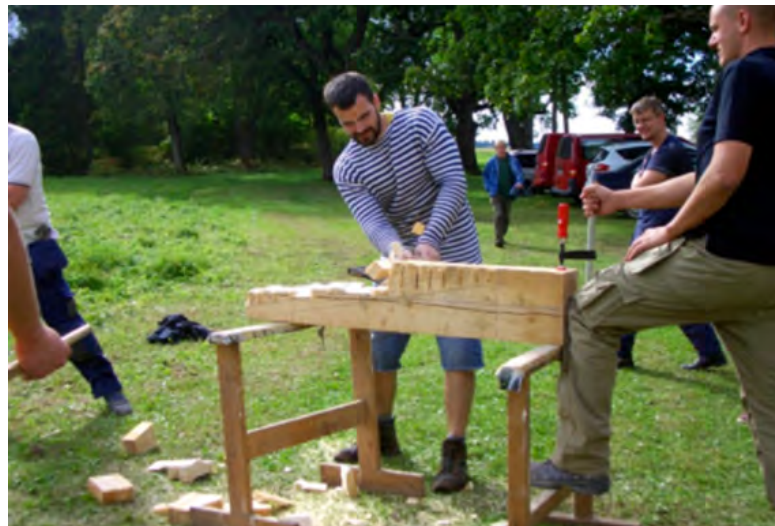
Figure 3.25. Here we learn how to hew the timber with an axe.

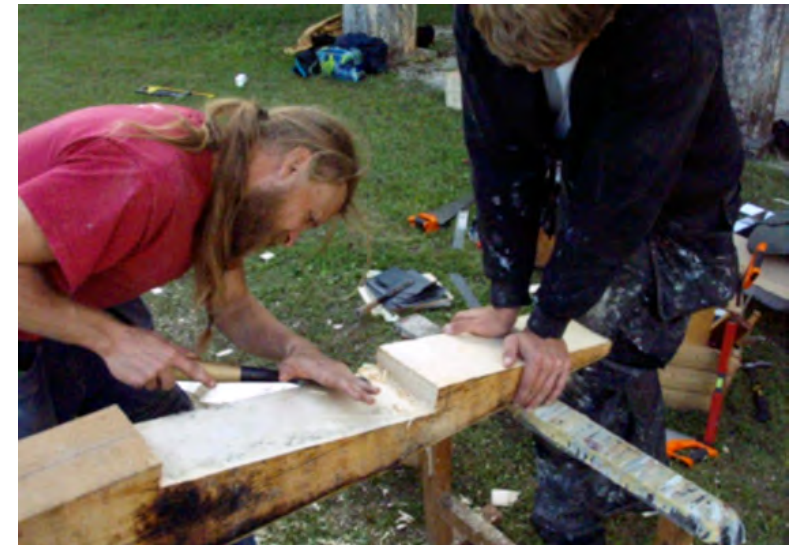
Figure 3.26. Then we learn how to carve with a chisel.

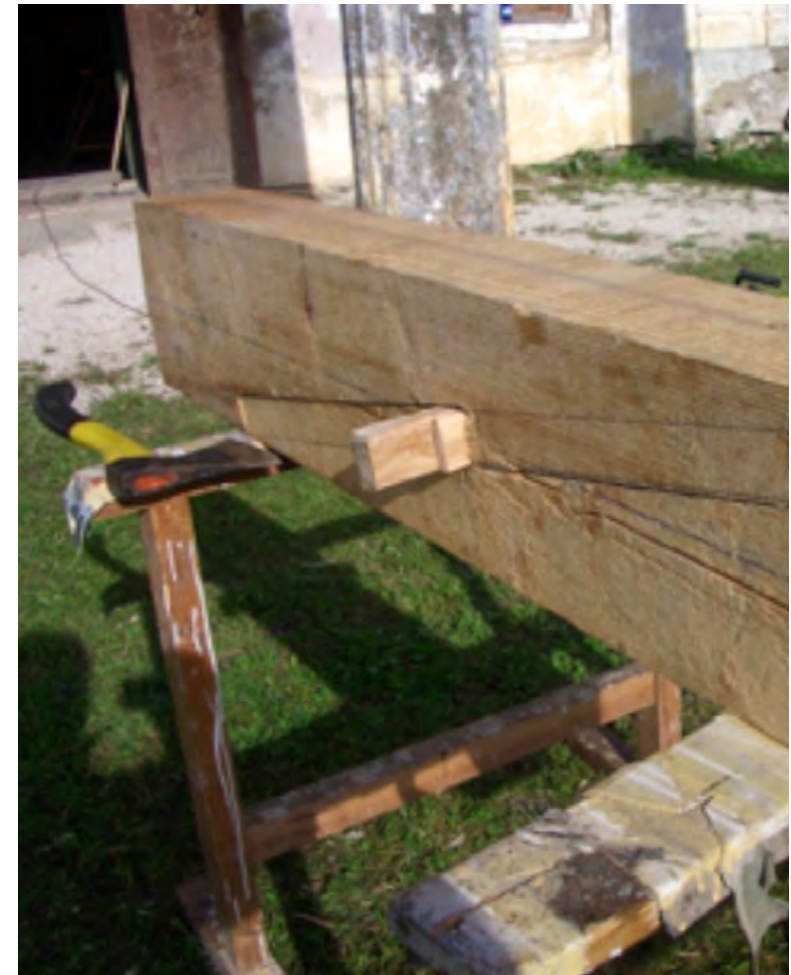
Figure 3.29. Here is a beam joint that withstands tension.

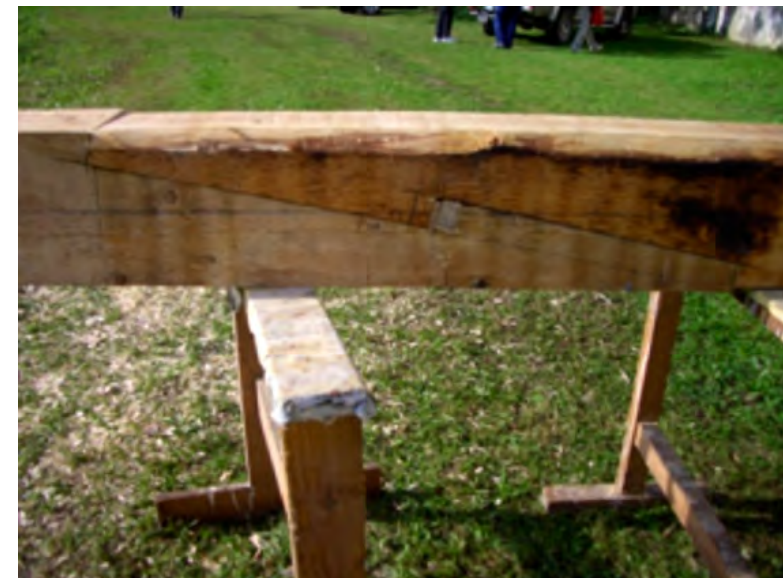
Figure 3.30. The finished joint.

Grinding and fine shaping: now we were left with a large surface that needed to be fine shaped, so that the two beams could be placed on each other. At first the shaping work was done by chisel and hammer, simply pounding pieces away without crossing the lines drawn in the beginning. When the wood started to take a finer form the work continued with the help of a plane. With the plane, the area that was to meet with the corresponding area of the other beam, was made smooth and nice so the two beams could meet exactly.

The key: the key ensured that the beams would not and could not separate. If you look from the side of the beam the wedge hole is square. When the two wedges are pounded in place from separate sides they secure the entire construction as planned.

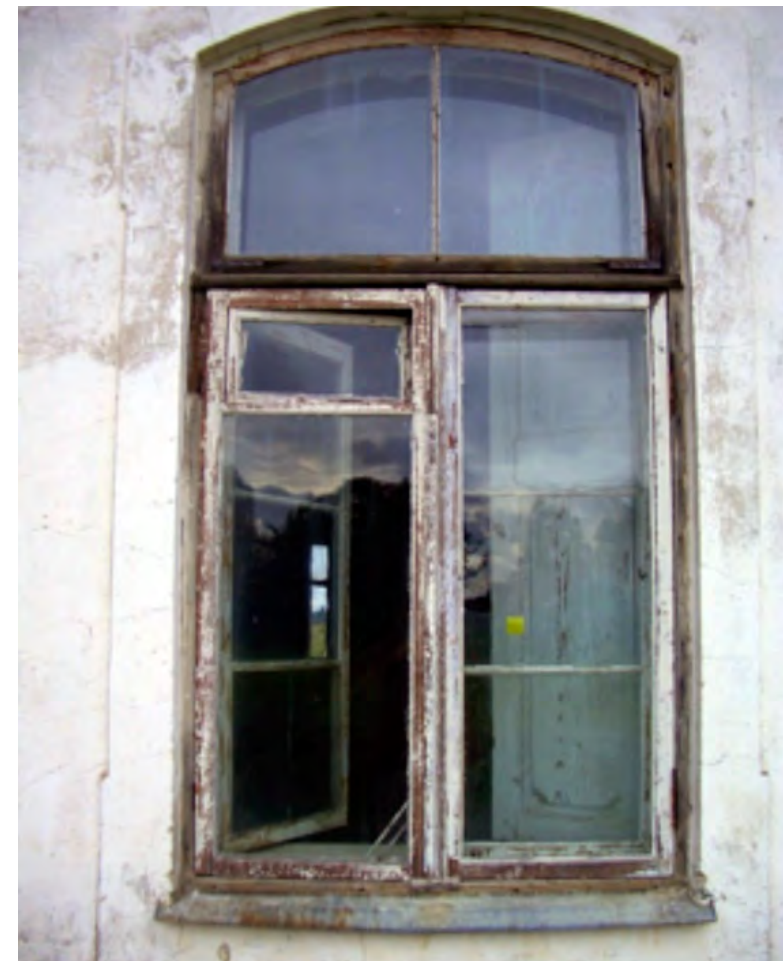
Figure 3.32. A typical window at Seidla Manor. Much work will be required.

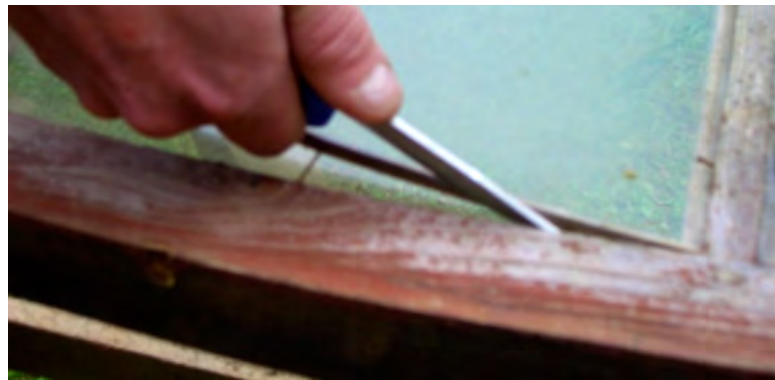
We discovered that no putty had been used between glass and casement nor between glass and glazing beads. At first the old decayed glazing beads around the glasses had to be removed. This was done carefully with a knife or a chisel. It had to be done with some precision so that neither casement nor glass would suffer any harm. The small nails were either removed by pliers or they could be pounded further in. When beads and nails were out the glasses could be removed. Casements and glasses were marked so that they could later be reunited.

Figure 3.33. A glazing bead is being removed.

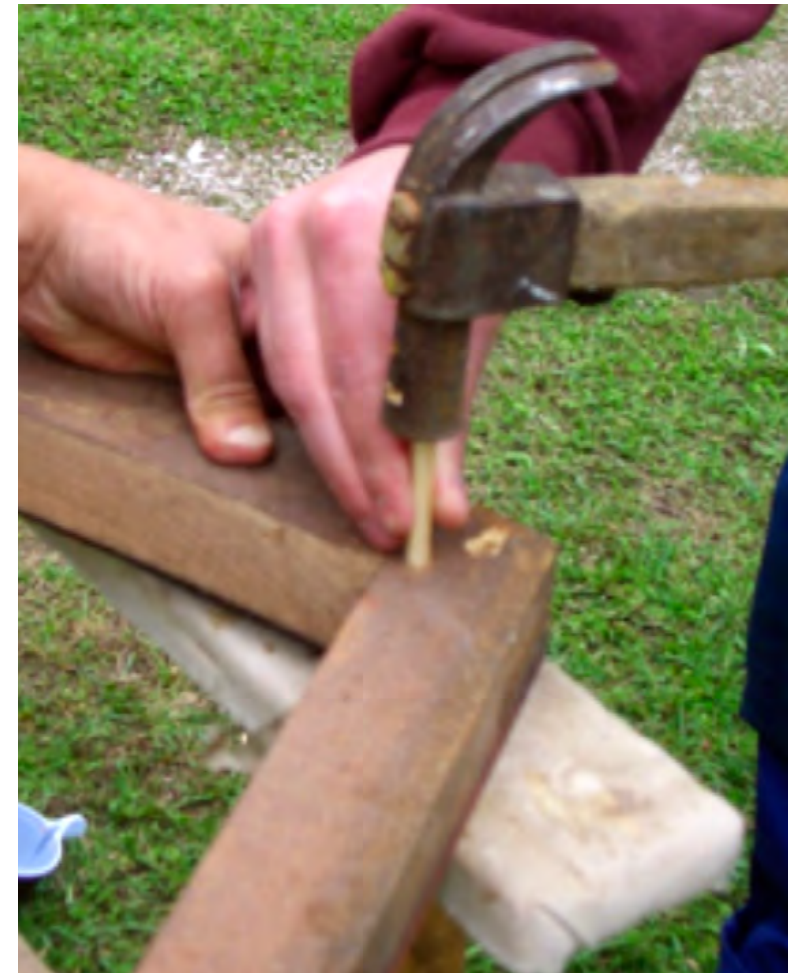
Figure 3.34. A new peg is being pounded gently into the casement of a window.

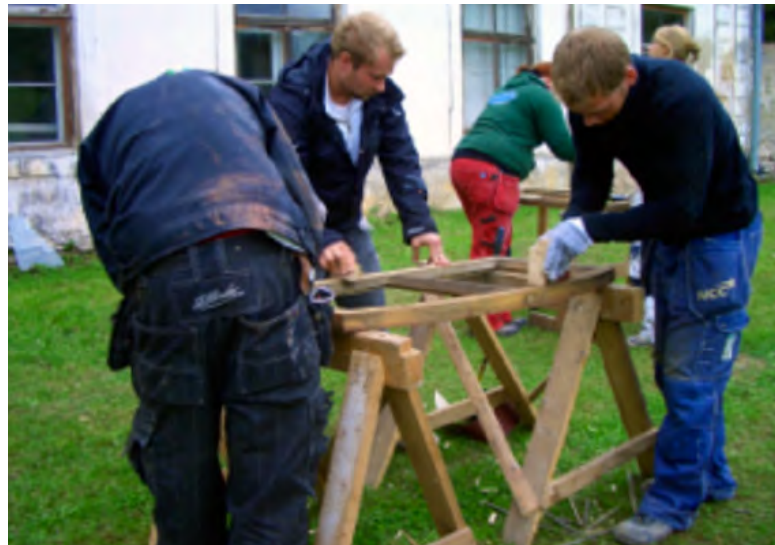
Figure 3.35. Sandpapering was quite easy as there was only one coat of paint to be removed and the wood was mostly in good condition.

Finishing: when the grinding part was over it was time to prime the surfaces with linseed oil. A few days later we could start reinstalling the glasses. The casement was placed on the worktable so that the inside of the window was down. A 1–2 mm thick bed of putty was pressed in the glazing groove. Then the glasses were reset on the bed of putty and pressed tight so that no air was left between glass and putty. When the glasses were in position small pieces of wood were pressed around them to keep them from sliding sideways. Next they were secured with the help of some small nails (preferably glazing points) which press the glass down as they are gently hammered into the surrounding wood. Finally the putty is inserted and trimmed with a putty knife so that it covers the nails and the groove (which is visible through the glass). Because traditional putty has the same binding agent as the paint, i.e. linseed oil, it can be painted as soon as it has been applied. Indeed, it is very important to paint it within a week or so to save it from drying and cracking.

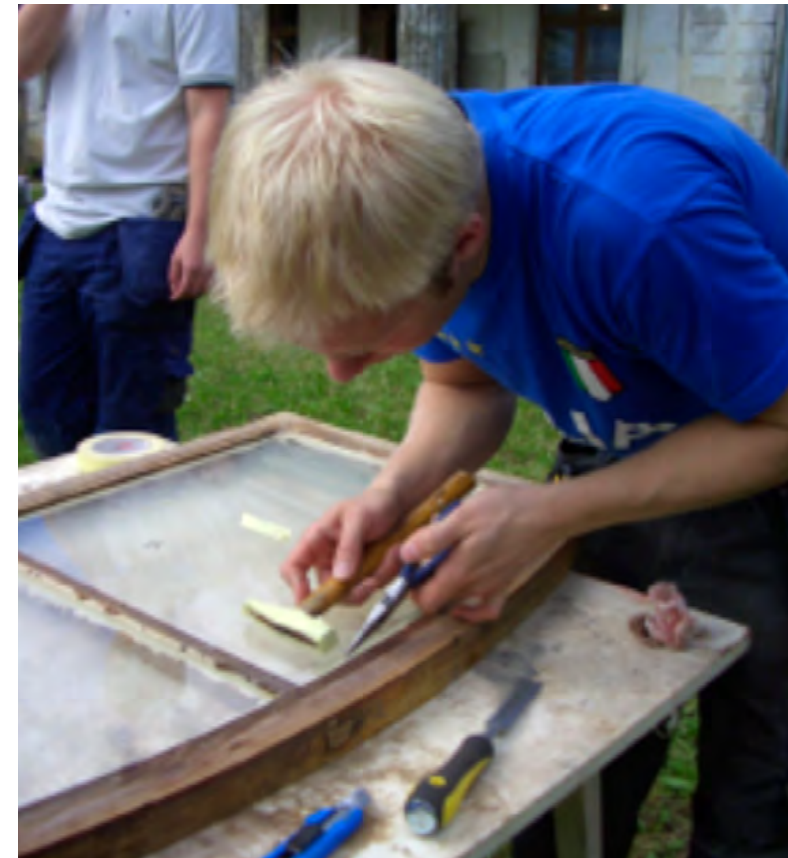
Figure 3.36. Nails are being inserted. The small hammer is wrapped in masking tape to avoid scratches on the glass.

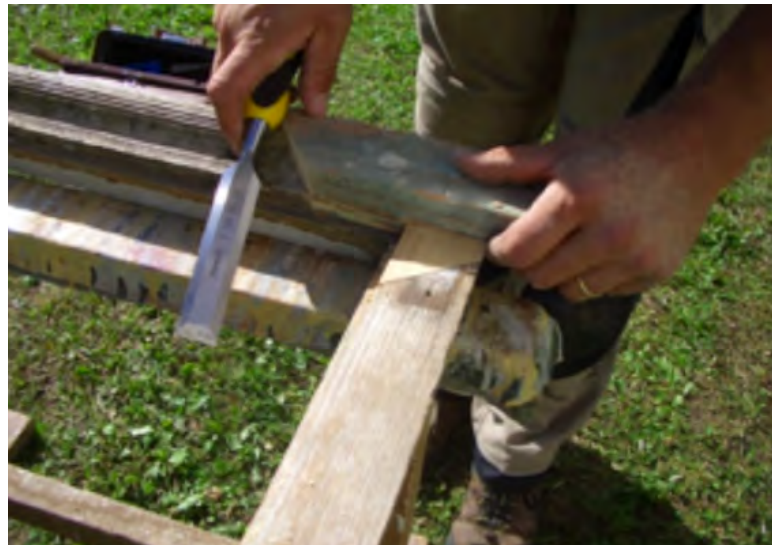
Figure 3.37. A new piece of wood has replaced an old decayed part.

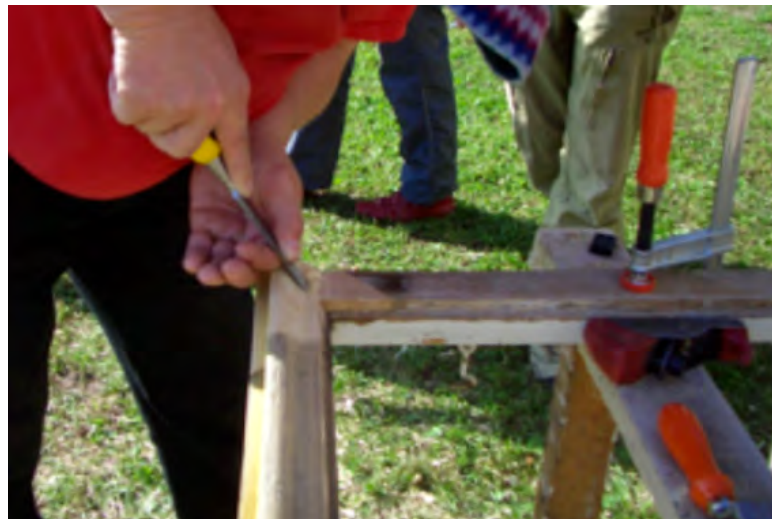
Figure 3.38. The new patch of the weather moulding is being shaped to match the old parts.

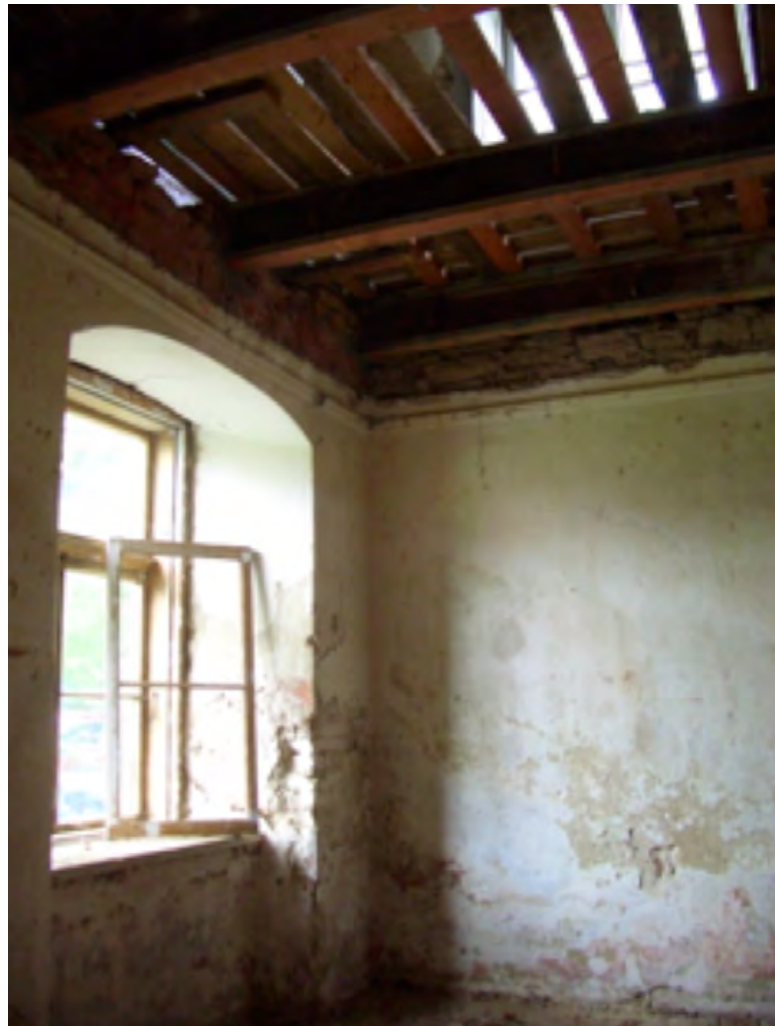
Figure 3.39. In some of the rooms at Seidla Manor there was neither ceiling nor cornice. Everything needs to be rebuilt.

- The walls (at least the upper parts of them) and the ceiling need no further repair or replacement of construction parts.
- Loose parts of the walls and old plaster are removed.
- Ensure that fixing of the new cornice to the walls and the ceiling is possible with appropriate methods depending on the construction materials used for each construction part.

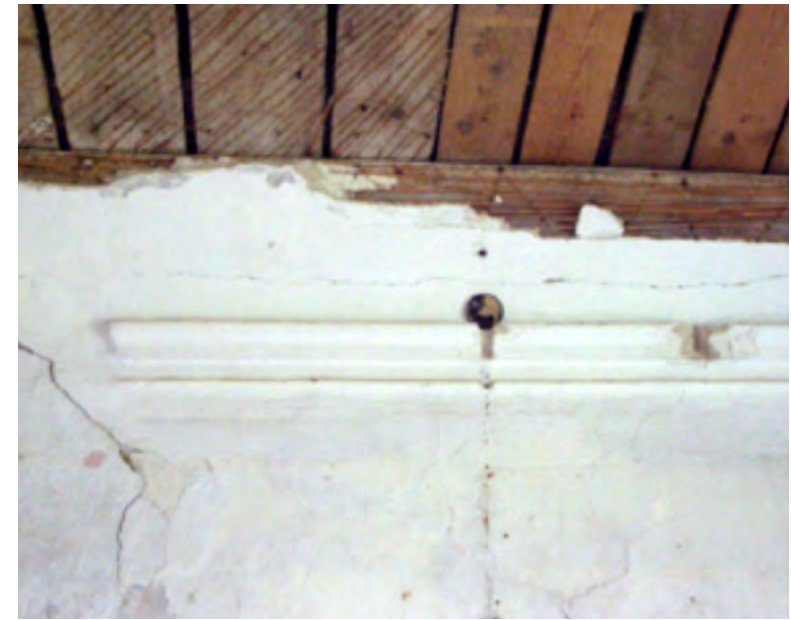
Figure 3.40. Plaster is removed from the ceiling and partially from the cornice. The ceiling needs insulation and the attic floor is missing, too. However, the timber frame of the cornice is most likely in good condition. The shape of the old cornice is possible to replicate.

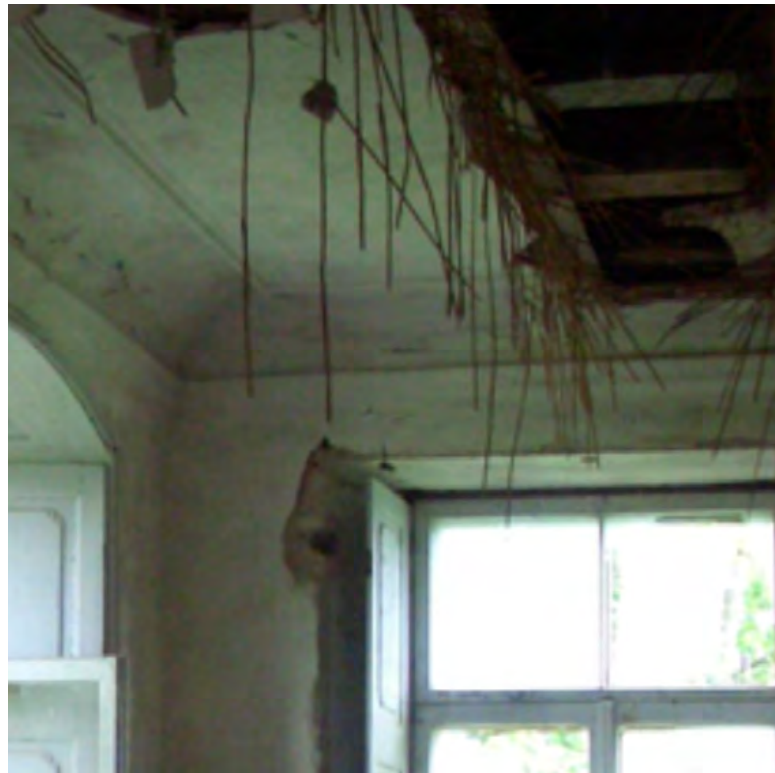
Figure 3.41. In some of the rooms at Seidla only the paintwork is damaged otherwise the cornice is in good condition.

If only the finishing coat is to be renewed dust and fat must be removed from the surfaces before treatment.

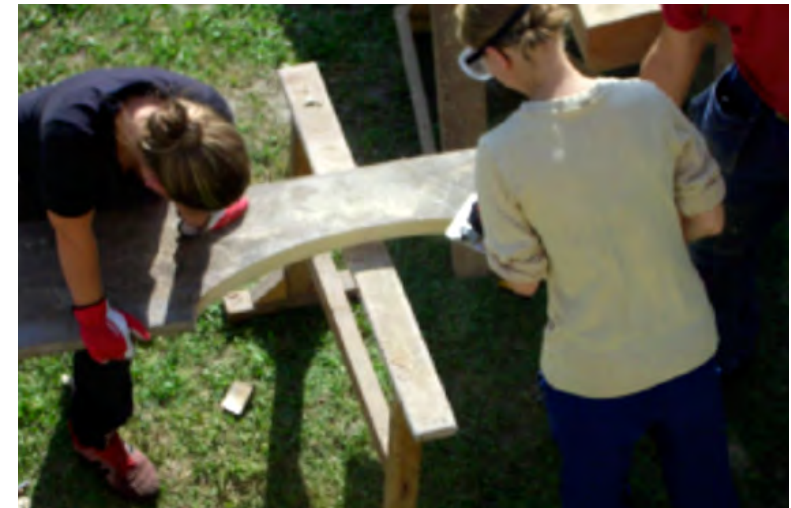
Figure 3.42. Consoles for the upper hall cornice are being made.

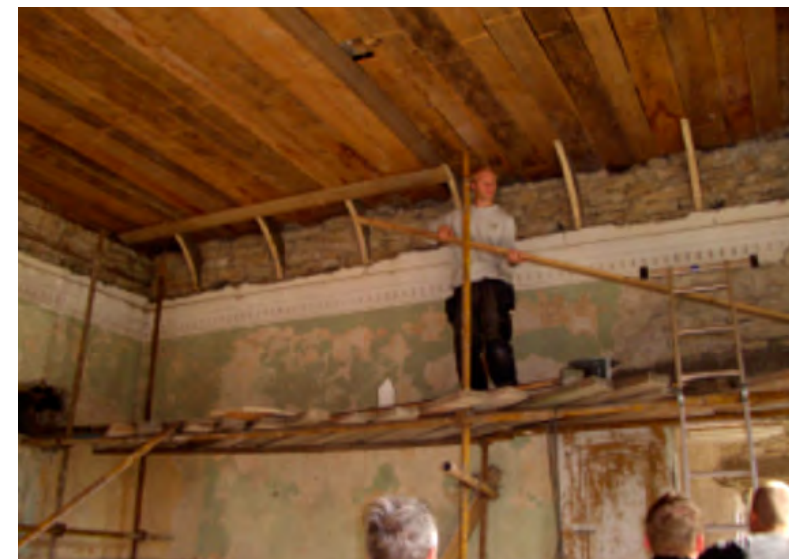
Figure 3.43. In the upper hall: new consoles are in place and planks are being attached to these. We finished the woodwork for the cornice along one wall.

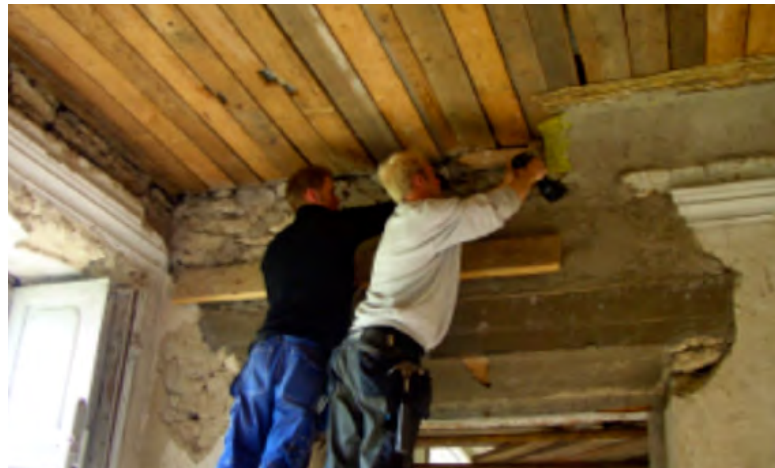
Figure 3.44. Reconstructing a cornice in one of the badly damaged rooms on the upper level.

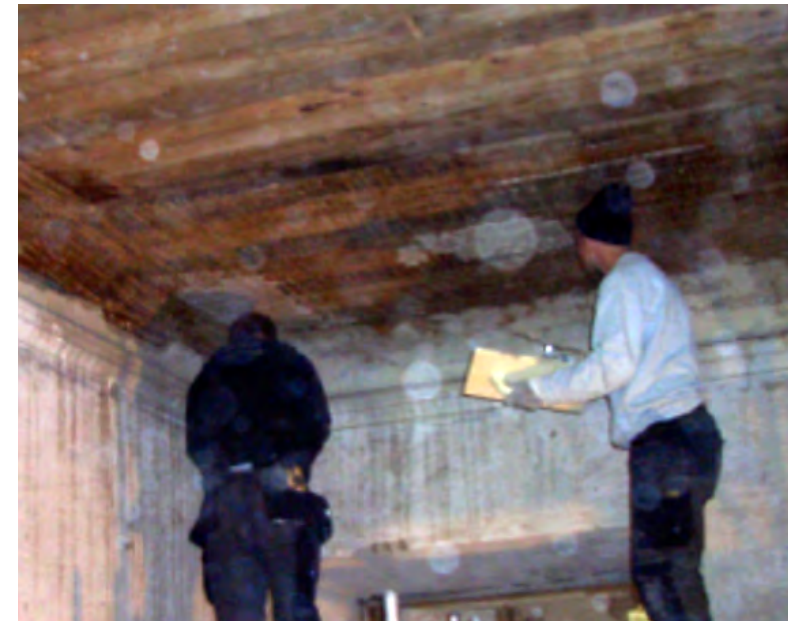
Figure 3.46. We were given a chance to try the traditional method of plastering the reconstructed cornice. This job is definitely something for experts!

Plastering: when preparatory work is done, form the consoles to the desired shape using appropriate tools, e.g. a jigsaw. Fix the framework of the cornice to the walls and the ceiling. Attach a reed web, or a plastic mesh, using staples or nails to the wooden surfaces that are to be plastered. Mix the plaster according to the original recipe and start applying this to the framework of the cornice. The plaster can be applied by throwing, pressing or spraying. The shaping of the cornice starts after the first layer of plaster has been applied. The shaping is done by dragging a stencil made of plywood, which is cut to the desired shape, along steering planks on the wall and the ceiling. The stencil can be reinforced with a metal plate. The shaping is done in as many layers as required. Do not apply too much plaster at a time.
